St. Thomas Electronic Records Disaster Recovery Effort

Technical Report RE0025

**Dr. John W.C. Van Bogart
John Merz**

**National Media Laboratory
November 1995**

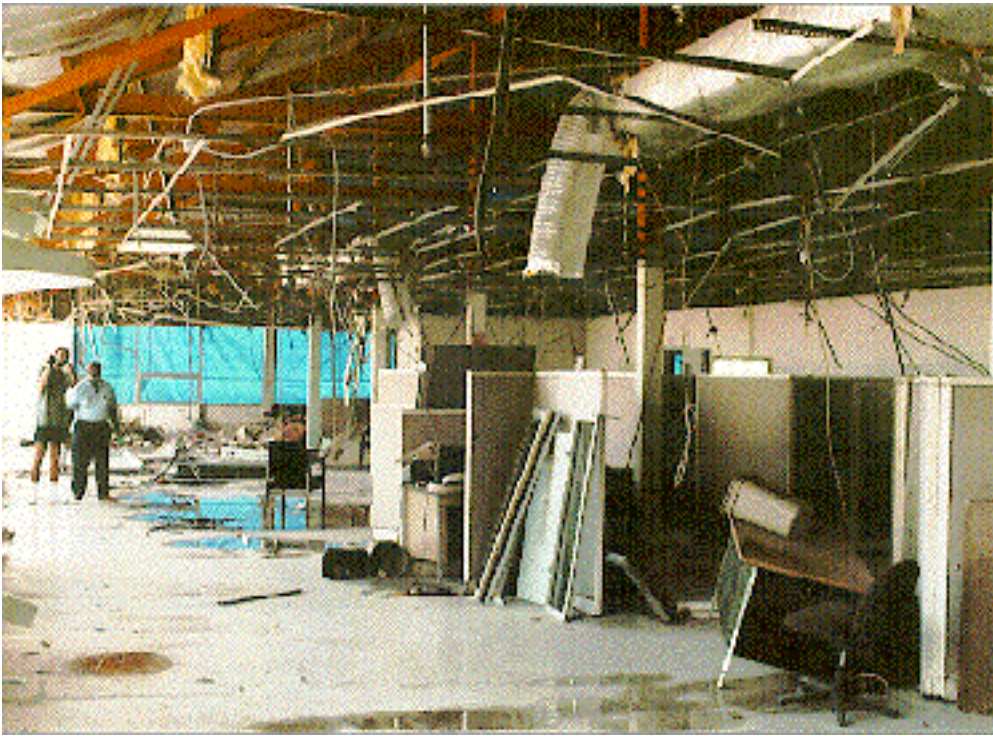
Figure 1: Condition of DPNR main offices in the wake of Hurricane Marilyn (after salvaging operations). Wall off to left of the photograph was literally blown away.

The USVI Legislature Building and the DPNR main offices were hardest hit by the storm. This was due, in part, to the fact that both were near the shore of St. Thomas Harbor and did not have the benefit of any natural protection from the winds (see Figure 1). Wind, rain, sand, and sea water entered USVI Legislature offices through a broken window and severely contaminated data storage systems. Sea water was the worst contaminant, causing appreciable corrosion of mechanical components and electrical connections. During and after a hurricane, even rain can contain salt-the violent winds pull sea spray into the atmosphere and deposit it in rain drops.

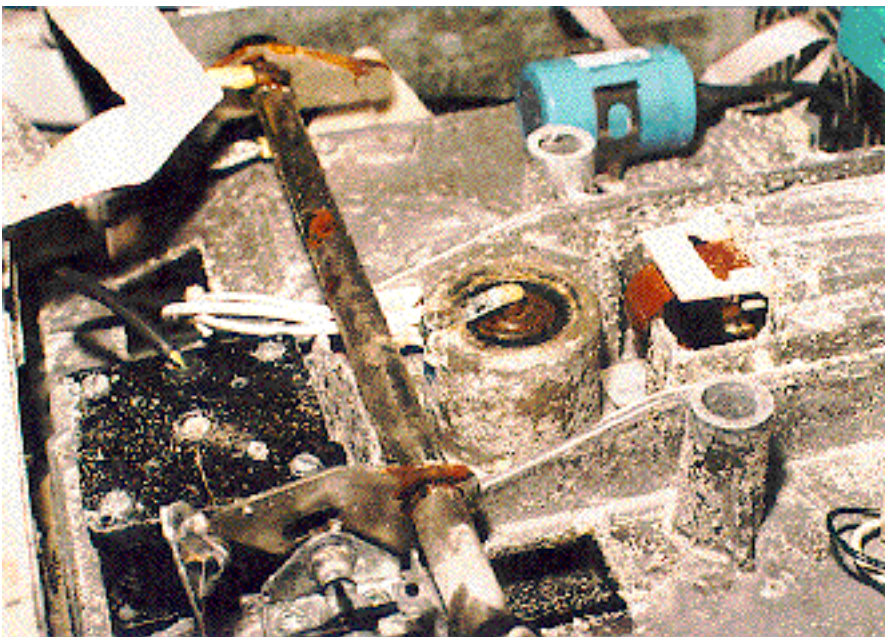
Figure 3: View inside one of the LMSI optical drives. The heavy whitish deposit contaminating the drive is a mixture of fine sand and salt.

Drives 1 and 2 showed signs of extensive sea water and sand contamination. Dried salt and sand were found throughout both units. Of the two, however, drive 1 was hardest hit. Metal parts were beginning to rust, notably the spindle motor bearings. Nearly every circuit board was caked with dried salt and sand. Drive 2 was in markedly better shape. Although salt and sand were found on most metal parts, circuit boards were not damaged. Drive 3 managed to escape contamination altogether. However, its "cartridge sensor" circuit board had already been tagged as defective. We decided to remove the tagged cartridge sensor board from drive 3 and replace it with drive 2's sensor board.

First, the cartridge sensor board was removed from drive 3 and re-installed in drive 2. We then removed as much sand and salt from the unit as possible using dampened swabs and compressed air.

The next day, we could not get the drive to spin up. Fortunately, the LD1200 is a very modular system making it easy to swap boards and other subsystems. However, every board in the unit (with the exception of the laser assembly) was swapped to no avail. The power supply was also swapped, but did not help.

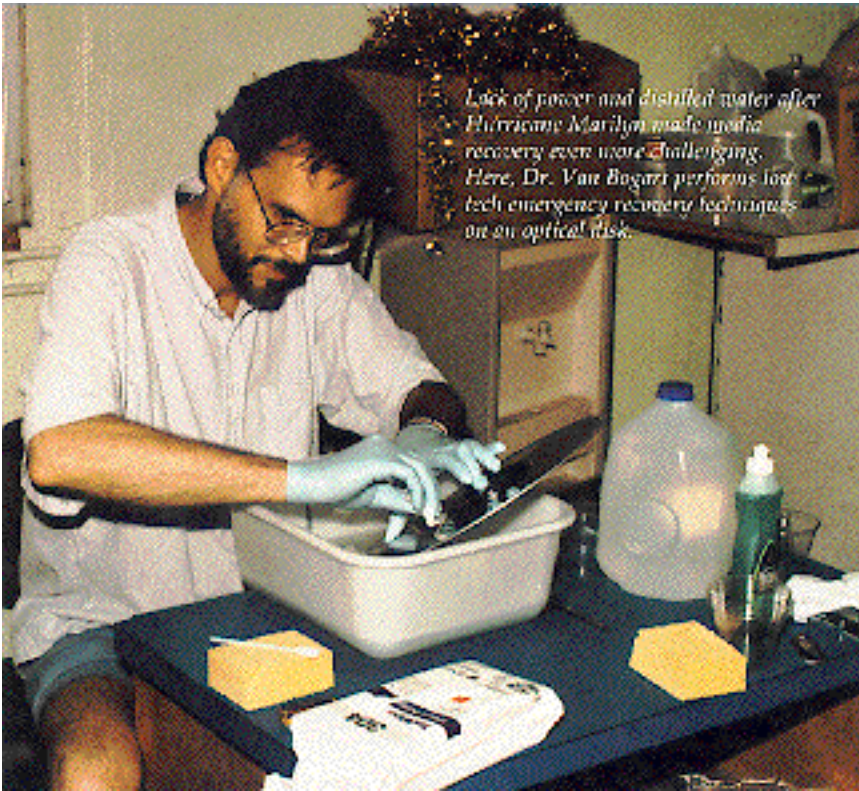
Figure 4: A 12-inch optical disc in the process of being cleaned. Disks were wiped in a radial direction—from the center of the disk to the edge. This minimizes the amount of data obscured on a given track in the event that the disk is inadvertently scratched.

The LMSI 12-inch optical discs from the USVI Legislature were not physically damaged in the storm. All contamination was superficial and data critical components of the disks were intact and uncorroded. Recovery of the optical media simply involved a very careful cleaning of the disks. Disks were first rinsed with a stream of water provided by squeezing a wet sponge to remove coarse debris. The disks were then gently wiped with a wet cotton cloth until all fine sand and salt residue had been removed. At no time were the disks immersed in water for fear that the water may have breached the laminated edges of the disk and contaminated the disk's reflective layer. Figures 4 and 5 show an LMSI disk being cleaned.

A cleaning station can be prepared by first taping a disposable plastic drinking cup (upside down) or other similar plastic support to the center of a washing basin. The cup serves as a support to keep the edge of the disk platter from being submerged in the water in the washing basin. When cleaning the disk, the disk platter can be supported on the upside down cup and against two adjacent sides of the wash basin. A small cotton TexWipe can be placed on the bottom of the upside down cup to reduce slippage of the disk against the cup. The disk is shown supported in this fashion in Figure 4.

Place water in the wash basin until it is 1 to 2 inches deep. Gently remove the disk from the cartridge and bring it to the cleaning station. Set the edge of the disk on the cup at the center of the wash basin. While holding the disk in place on the cup with a thumb, lay the disk over into one of the corners of the wash basin so that it is supported by two adjacent sides of the wash basin (see Figure 4).

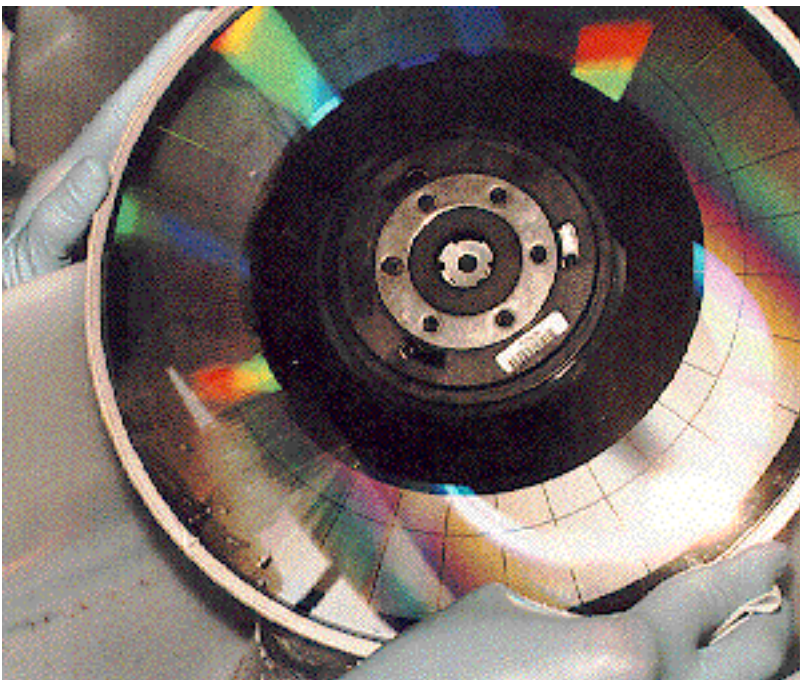
Figure 5: 12-inch optical disc in the middle of cleaning. The right portion of the disk has been cleaned; the left portion of the disk is covered with a film of fine sand and salt. In the photograph, remaining debris appears as a haze on the disk.
